Rolling contact fatigue (RCF) defects of rails in Japanese railways and its mitigation strategies

Makoto ISHIDA

Railway Engineering Department, Nippon Koei Co Ltd, Tokyo, Japan

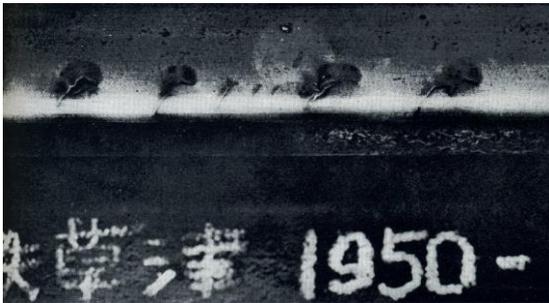
Fig.1 Dark cracks in gentle curves

The Japanese history of RCF defects in rails is described mainly based on some findings and research achievements obtained so far by Railway Technical Research Institute (RTRI) and Japanese railway operators in Japan. Basically RCF defects must have been initiated just after steel wheel-on-steel rail system was developed. But the first comprehensive report on RCF defects in rails was written by a research project group in RTRI organized by Japanese National Railways (JNR) in 1952¹⁾. At first some defects called “dark cracks” shown in Fig.1 in those days were observed in gentle curves in San-yo line of JNR. Typical cracks were caused together with head checks as shown in Fig.1. The naming of dark cracks is based on superficial feature that some part surrounding cracks look dark presumably due to slightly indented surface. Then such dark cracks posed so serious problem that a research project was

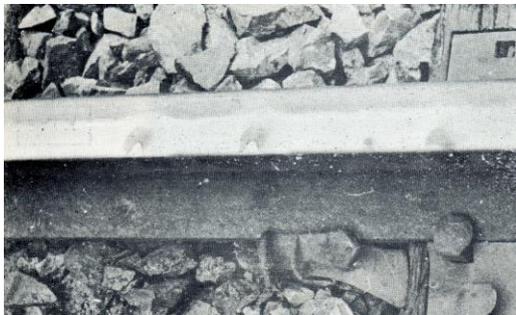
Fig.2 Dark cracks in tangent track

established to study the mechanism of crack initiation following dark cracks. Those cracks were observed not only in curves but also in tangent tracks. Fig.2 shows dark cracks take place in tangent tracks.

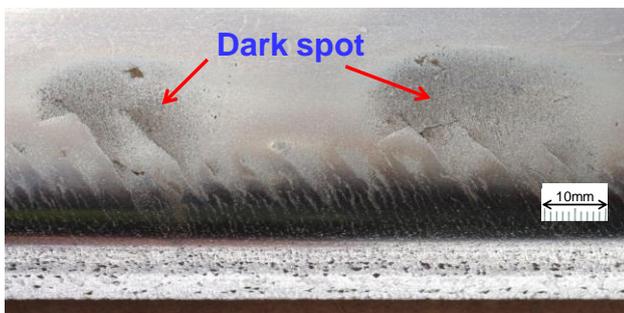
Fig.3 Gauge corner cracks

Shortly afterwards they came to be called shelling and/or rail surface shelling which is named to differentiate gauge corner shelling which is called as one of the typical fatigue defects of rail reported in heavy haul railways²⁾. Also, after Hatfield accident³⁾, gauge corner cracks shown in Fig. 3 were focused on to understand their mechanism and establish some appropriate preventing and/or mitigating measures.

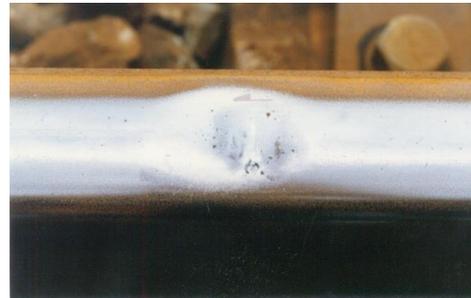
Fig.4 Typical RCF defect "Squat" called in UK and rail surface shelling called in Japan

cracks look so similar each other not only superficially but also mechanically and metallurgically. Then the mechanism of initiation and propagation of those two cracks may be the same. In addition, gauge corner cracks are classified to rail surface shellings called in Japan or squats called mainly in UK shown in Fig.4, which is commonly accepted in Japan.

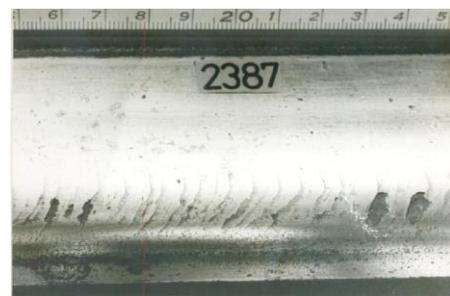
Fig.5 Head checks in as-rolled rail

But of course gauge corner cracks are usually caused under head checks generated at gauge corner. And gauge corner cracks are generated not just at gauge corner but slightly close to the centre of rail crown from the gauge corner. The influence of head checks on the initiation of gauge corners has not been clearly understood yet. Also, gauge corner cracks don't necessarily occur at the location where head checks are observed. Head checks shown in Fig. 5 in the case of as-rolled rails and in Fig.6 in the case of head hardened rails are formed at almost all curves which mean, for example, at transition curves in the case of sharp curves and at circular curves in the case of gentle curves. In these figures, the crack spacing of as-rolled rails is larger than that of head hardened rails, the reason for which is not clearly understood.

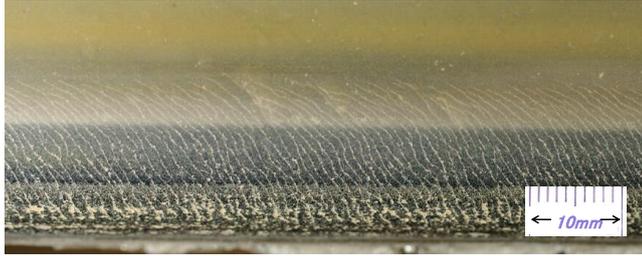
Fig.6 Head checks in head hardened rail

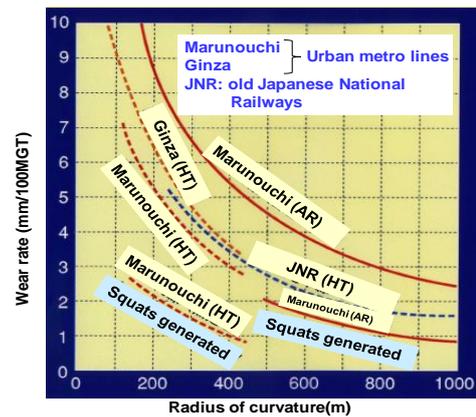
Fig.7 The correlation between wear rate and RCF defects initiation with the parameter of radius of curvature (AR: as-rolled rail, HT: heat treated rail = head hardened rail)

In 1970s gauge corner cracks which were called as shellings at that time in Japan as mentioned above posed a large problem in underground railways in Tokyo. Similar to “dark cracks”, an investigation committee was established to understand the mechanism of such RCF defects^{4),5)}. In the investigation report, less wear was newly pointed out similar to dark cracks and also the effect of lubrication on the initiation and propagation was pointed out. So the some appropriate amount of gauge face wear of rail was studied. For the time being, some head hardened rails were changed to as-rolled rails to increase wear to mitigate RCF damage. Fig. 7 shows the correlation between wear rate and RCF defects initiation with the parameter of radius of curvature. This figure shows both of head hardened rail and as-rolled rail may be suffered from RCF defects, squats or gauge corner cracks, in the case of less wear.

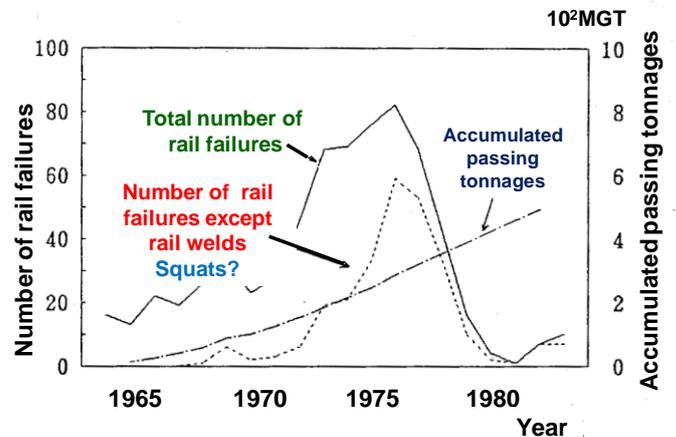
Fig.8 Transition of annual rail failures and accumulated passing tonnages in Tokaido Shinkansen (JIS50T rail)

First stage of rail surface shelling problem in Tokaido Shinkansen which is the first Japanese high speed line opened in 1964 was raised. Since then most of the rail failures were related to rail welds. But the number of rail surface shellings had been increasing after about 10 years passed since starting its operation. Fig.8 shows the history of the number of rail failures in Tokaido Shinkansen.

In this figure, the number of rail failures located not at rail welds was increasing up to 1985. At that time rail surface shellings were not clearly identified by track maintenance people necessarily because the training for the track maintenance people was not enough to check the rail surface shellings, which means obtained data may have included unsuitable ones. But roughly speaking, the trend of changing the main factor of rail failures from rail welds to rail surface shellings can be identified. However fortu-

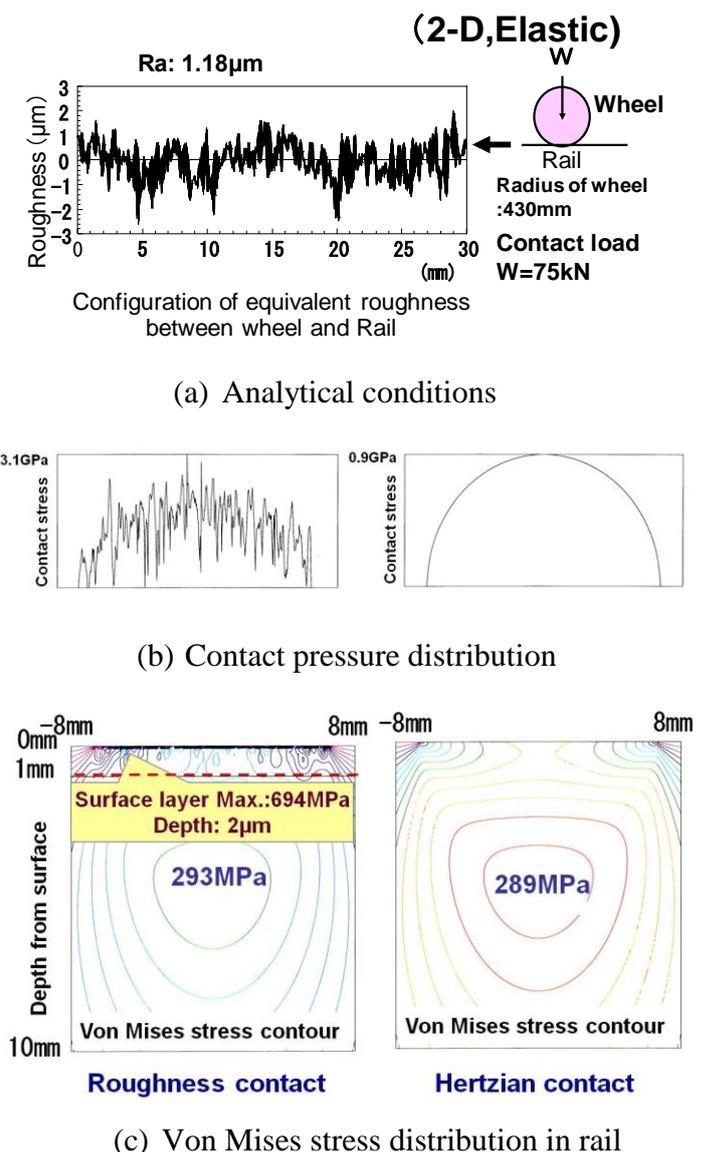
Fig. 9 The effect of roughness at wheel/rail contact interface on stress distribution

Fig. 9 shows the analytical conditions and its results with 2D roughness contact model constructed by Dr. Franklin and Prof. Kapoor under the collaboration between Sheffield Univ. and RTRI^(7),8).

In this figure, with regard to contact pressure between rail disc and wheel disc, roughness contact pressure is much larger than Hertzian contact pressure. Also, with regard to Von Mises stress distribution, the maximum of Von Mises stress is located at the surface or very thin layer of the surface under roughness contact and no such a high stress takes place under Hertzian contact. Since this 2D analytical model is elastic and two dimensional, the analytical results don't have agreement with actual wheel-rail contact stress condition but suggest some important tendency of stress distribution to roughly understand the damage of rail material. From the analytical results, the damage of rail should be very large at very thin surface layer, which can lead to the effect of preventive grinding.

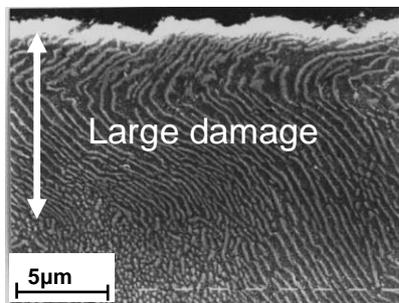
Fig. 10 Plastic deformation at the contact surface layer of actual rail material

Also, Fig. 10 shows the plastic deformation at the surface of actual rail material. This figure roughly indicates the adequacy of the 2D analytical model and the possibility of RCF crack initiation at the very thin layer.

Also, it suggests the possibility that effective grinding thickness should be more than 10 microns and less than 0.1mm of rail subsurface combining with analytical results of 2D roughness model. In addition, focusing on the slip plane of metallic crystal, it is identified that the direction of some specific slip planes is deformed to the same direction plastically under repeated loading⁹⁾. Considering above-mentioned analytical and practical information, the grinding thickness was set to be the only variable parameter and other parameters were constant under the grinding frequency of 50MGT in the experiments using a large twin disc machine. Before grinding ex-

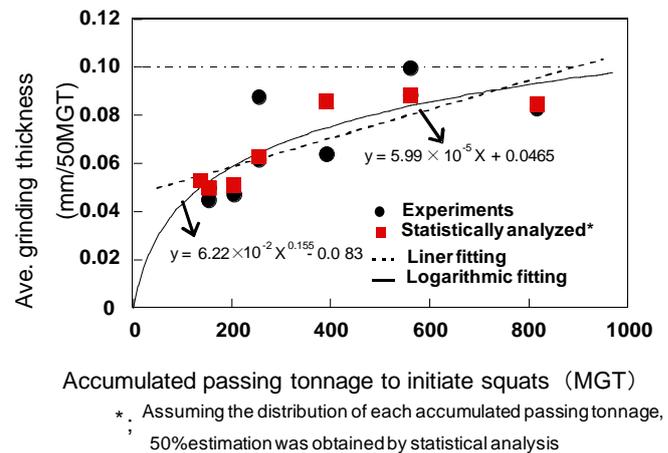
Fig. 11 The effect of preventive grinding on accumulated passing tonnages to initiate squats

Fig. 11 shows the results of grinding experiments with the large twin disc machine¹¹⁾. In this figure, some regression curves were obtained to estimate the effect of grinding on RCF. Roughly speaking, 0.1mm of grinding thickness every 50 MGT has an appropriate effect of grinding to extend the service life of rail up to averagely 800MGT.

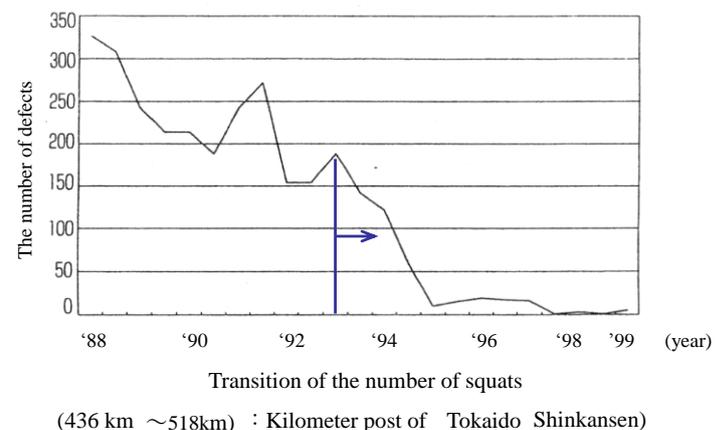
Fig. 12 The effect of preventive grinding on mitigating the initiation of RCF defects (after 1993, whole main line of Tokaido was covered with grinding operation)

The adequacy of this preventive grinding method, 0.1mm/every 50MGT was verified in the operation of Tokaido Shinkansen. Roughly speaking, all rails installed in the main line of Tokaido Shinkansen have been ground once a year, about 40 to 50 MGT of annual passing tonnages since 1993. Fig.12 shows the results of detecting rails in the monitoring section of Tokaido Shinkansen⁷⁾. In this figure, the number of defects dramatically decreased since regular preventive grinding started in 1993.

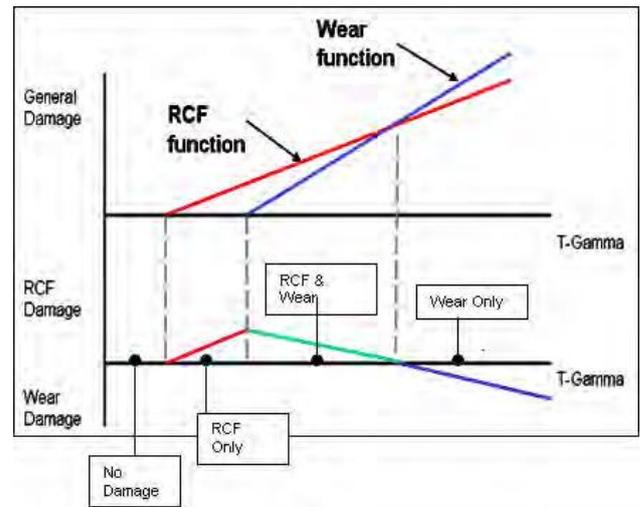
Fig. 13 The concept of T-gamma model describing the balance between wear and RCF

After the Hatfield accident, the whole life rail model and T-gamma model were established^{14),15)}. Fig. 13 shows the concept of T-gamma model. This model is based on friction energy and material strength. According to friction energy, balance between wear and RCF can be evaluated, which is very helpful to select material level and strategy of lubrication and/or grinding. I hope the meaning of damage function should be clearer, for example, RCF function is the rate of crack propagation or plastic deformation and wear function is wear rate and so on. Then the next research subject will be expected to define the damage function.

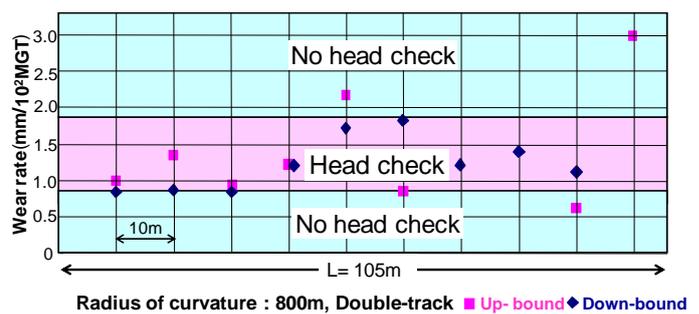
Fig. 14 The relation between wear rate and head checks (heat treated head hardened rails)

Also, head checks can be generated by the balance between wear and fatigue, which means head checks must be one of RCF defects. Fig. 14 shows the some range of wear rate where head checks are likely to initiate even if the data are very limited.

In the figure, very small amount of wear rate means damage is very less, too, middle range amount of wear rate means suitable balance between wear and RCF for head check initiation, and large amount of wear rate means fatigue damage is not accumulated and worn out.

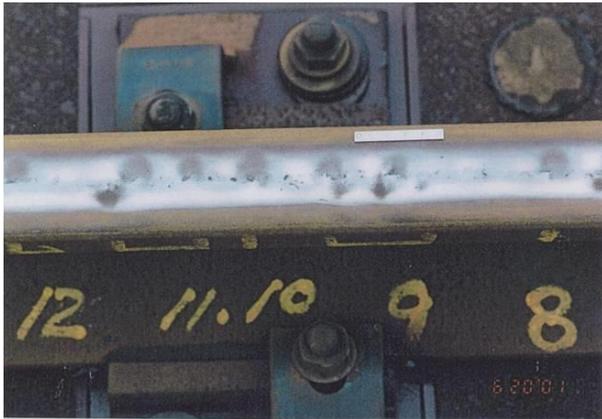
Fig. 15 Squat type of RCF defects related to white etching layer

Also, some reports have been already published in other railways^{18),19)}. Fig. 15 shows typical squat type RCF defects of white etching layer. Fig. 16 shows microstructure of white etching layer.

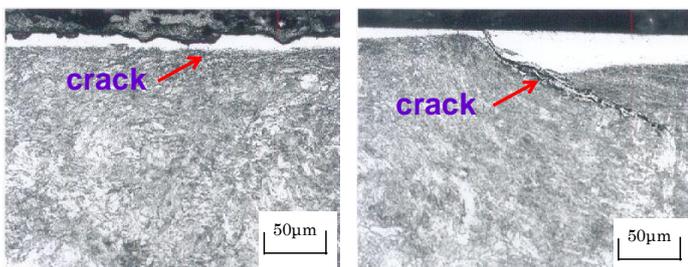
Fig. 16 Micro-structure of white etching layer
